The REMR Bulletin

VOL 6, NO. 5

Diamond Wire Cutting Used on Concrete at Marseilles Dam

Evaluation of Water Jet Blasting for Removal of Concrete From Lock Chamber Faces

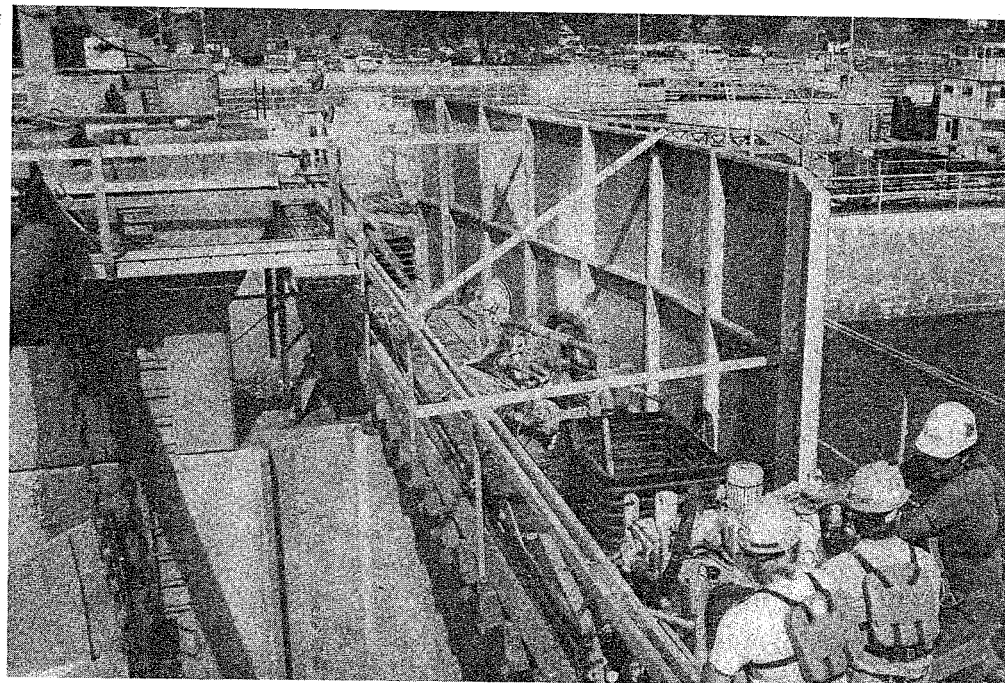
Diamond wire saw set up on Lock No. 20, Mississippi River

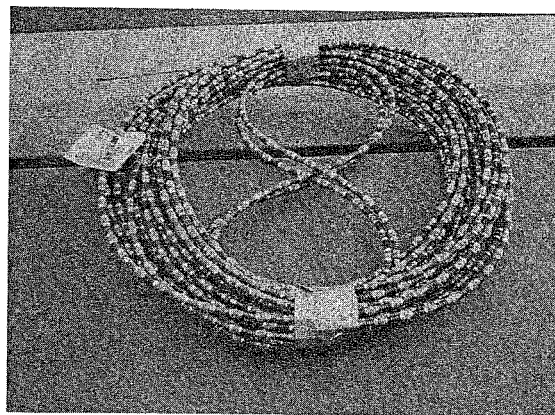
Figure 1. Saw wire, showing beads and spacers

The diamond wire cutting was subcontracted to a private firm. The equipment used on the job consisted of a 4-ft-cube, 1,200-lb power unit; a 3- by 4- by 8-ft, 1,400-lb saw; idler wheels; and a wire loop. The electrically driven (440 v, 50 amp) power unit supplied hydraulic flow to the saw motor. The saw was comprised of a flywheel, its motor, and a hydraulic stroke cylinder. The stroke cylinder positioned the flywheel to create the desired tension in the wire loop. Idler wheels were used to guide the wire and to direct the cut. The wire was a steel wire rope encased in a series of alternating beads and spacers (Fig. 1). The beads were steel with embedded diamonds, and the spacers were injected plastic sleeves. Two sizes of wire were used, a 3/8-in. wire that had beads with electroplated diamonds and a 1/2-in. wire that contained beads with impregnated diamonds. Beads with impregnated diamonds have a longer cutting life; however, they are more expensive and slower cutting (wires with plated diamonds and steel spring spacers seemed to be the subcontractor's preferred choice for a recent project).

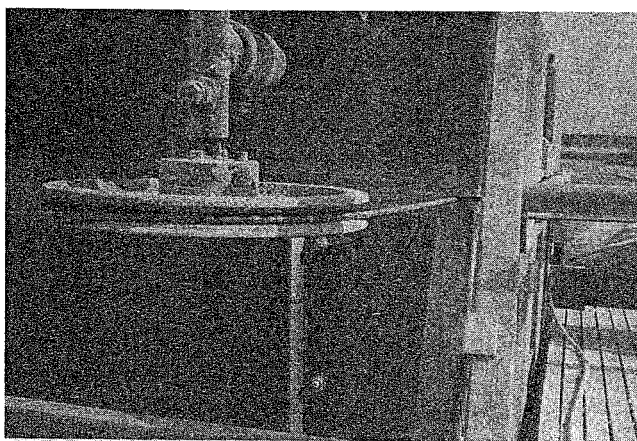
Figure 2. Starting a cut on Lock No. 20

Diamond wire cutting has since been used at Mississippi River Lock and Dam No. 21 and is presently being used at Mississippi River Lock and Dam No. 20 (Figs. 2-4).

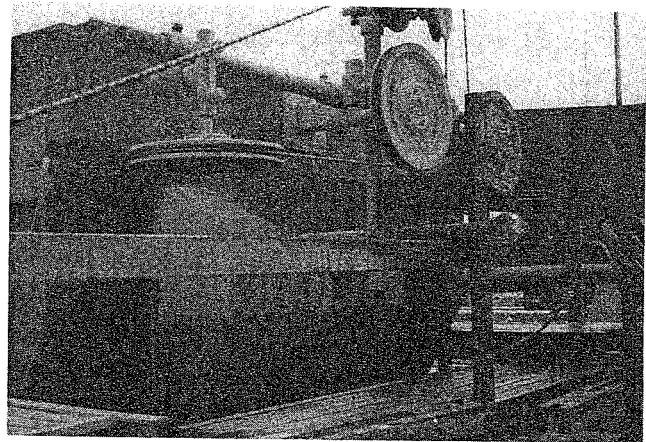
Figure 3. The saw has cut deeply into the concrete

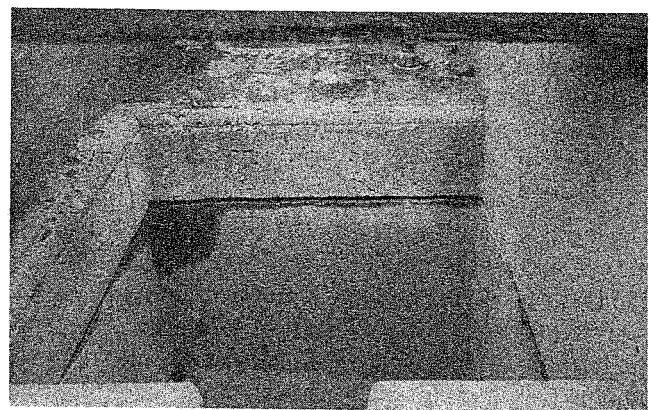
Figure 4. Completely sawed section on Lock No. 20

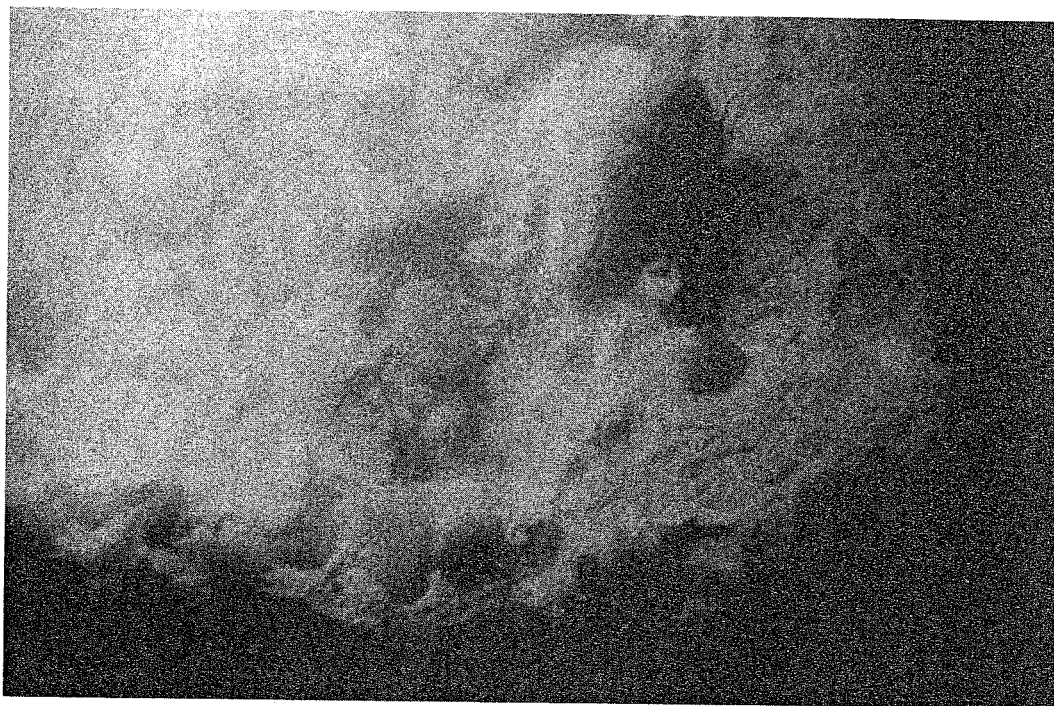
Figure 1. Results of underwater removal 4-ft below water surface

The underwater operation took place during a 2-hr period with 0.3 cu yd of concrete removed between the pool elevation and 4 ft below (Fig. 1). Removal depth averaged 4.5 in. Underwater, the removal rate was approximately 35 percent less than that above water. It is suspected that the concrete below the waterline was sounder, primarily because it had been protected from cycles of freezing and thawing by the surrounding water and therefore was more difficult to remove. The underwater rate would have been somewhat less if the removal had continued to a 12-in. depth because of loss of cutting efficiency with depth.

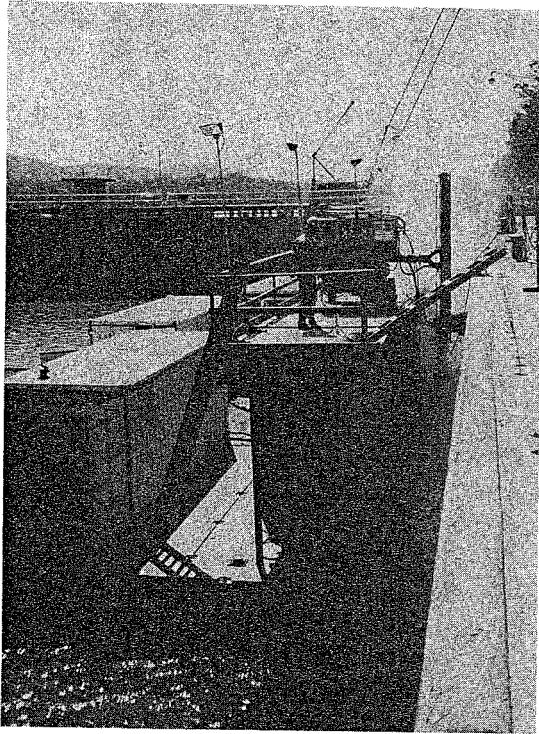
Figure 2. Water jet blasting of land wall chamber face

Filter system and power pack were loaded on the barge deck. The robot was loaded on an elevated deck constructed along the edge of the barge (Fig. 2). The barge was maintained at a fixed distance from the wall by brackets constructed at the ends of the barge (Fig. 2). Blasting started near the upstream gate recess and proceeded downstream, removing a strip of concrete between the

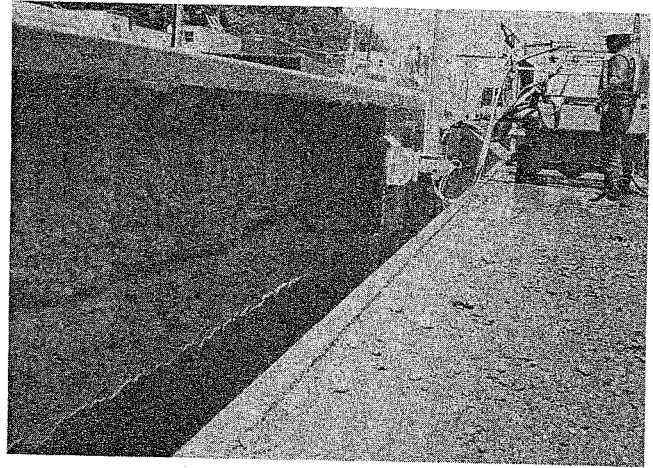
Figure 3. Removal strip

horizontal armor at the top of the wall to approximately 3 ft below (Fig. 3). The blasting produced ragged edges along the removal boundaries. Removal depth was approximately 12 in., except at horizontal lift joints where the removal depth was around 17 in.

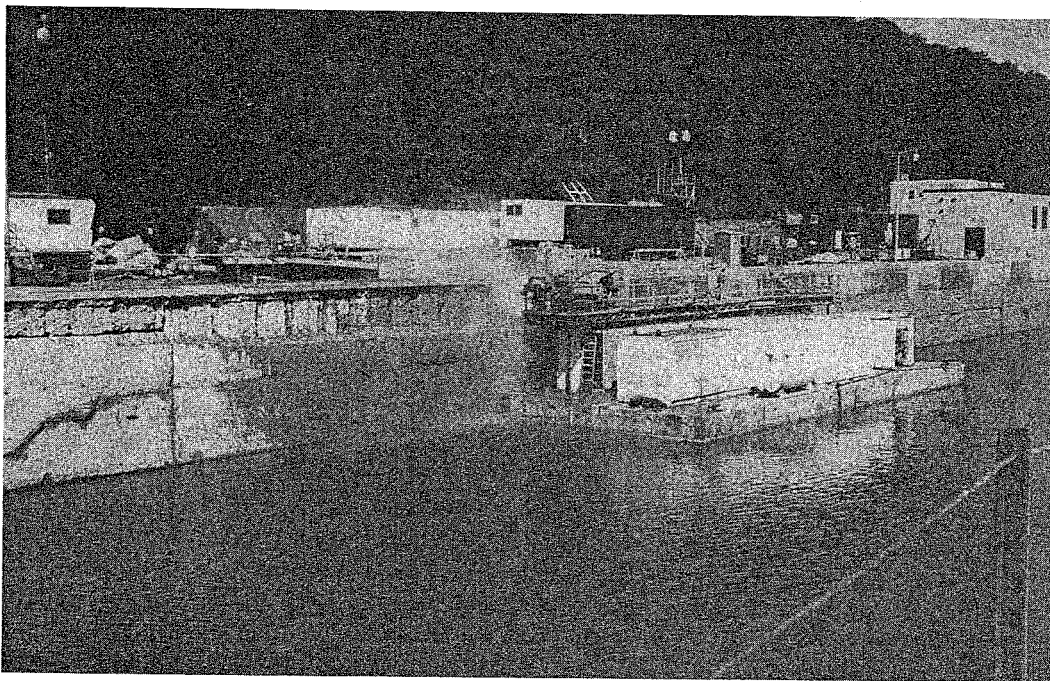
Figure 4. Water jet blasting as viewed from across lock

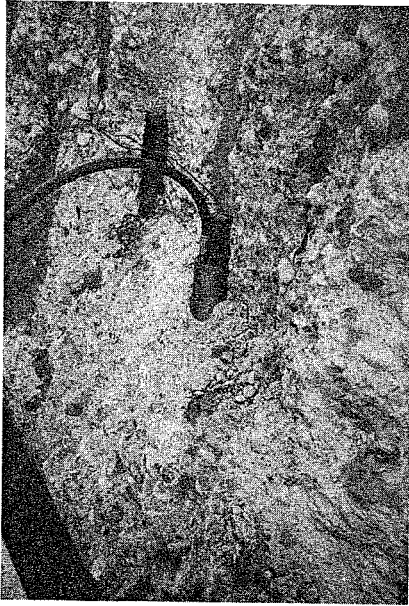
Figure 1. Rock jack connected to hydraulic hose

With the assistance of their parent company, located in Germany, the contractor chose to remove the concrete with hand-held rock jacks manufactured in West Germany. The assemblies, which were designed for use in a predrilled hole, consist of a cylindrically shaped jack approximately 14 in. long and 3-1/4 in. in diam with several lateral pistons exerting an outward force against a backer bar. The hydraulic pressure which operates the pistons is created by a portable hand pump which is connected to the jack (Fig. 1) by a 4- to 6-ft length of hydraulic hose (Fig. 2). The jack is inserted its entire length into a predrilled hole of a slightly larger diameter and pressure is then exerted against the backer bar. The jack develops a radial crack projecting several feet beyond the circumference of the hole (Fig. 3). The direction of the crack is controlled by the orientation of the pistons and the presence of adjacent line-drilled holes.

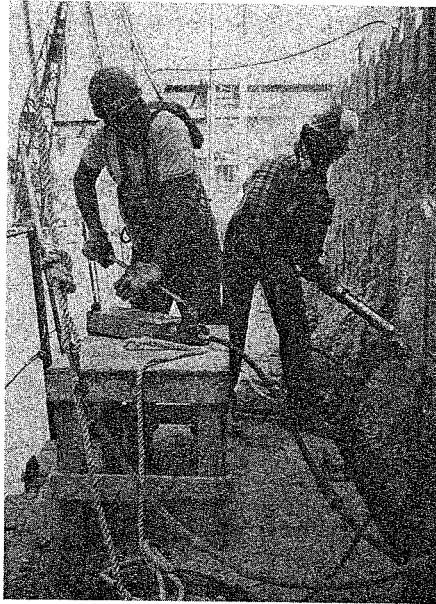
Figure 2. Worker using the portable handpump to create hydraulic pressure for rock jack

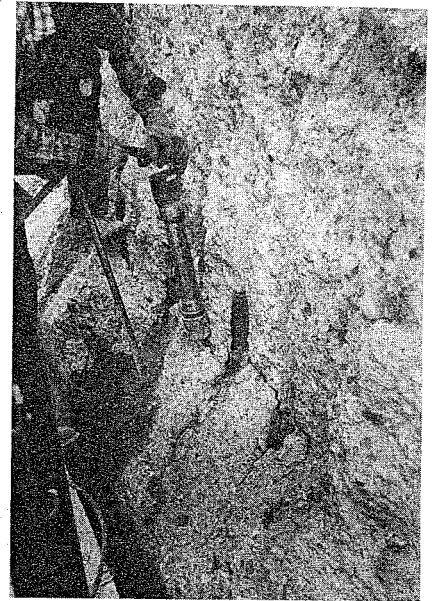
Figure 3. Radial crack developed with rock jack

In practice, a crack was initiated by pressurizing the first jack. As soon as the crack had propagated through the second and third holes, pressure was then applied to the second jack, causing

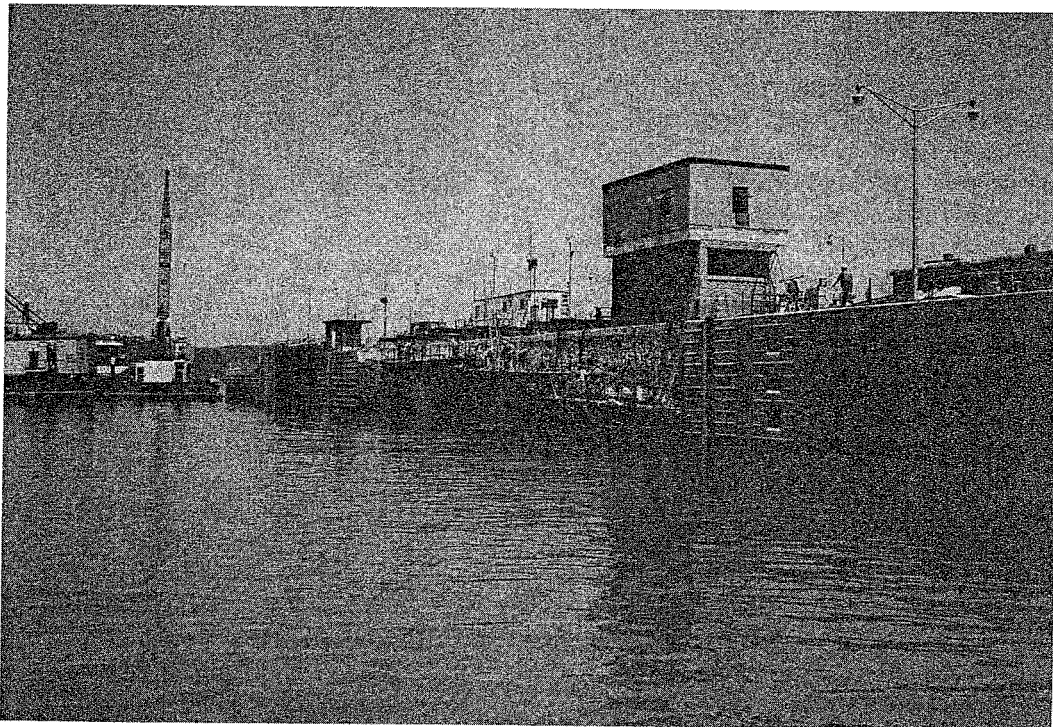
Figure 4. Suspended scaffolding at Dashields Lock and Dam Project

Most of the removal work was performed by laborers working from suspended scaffolds (Fig. 4). The concrete was removed in horizontal strips approximately 1 to 1-1/2 ft in height, working

Since the individual concrete pieces most often fell onto or against the suspended scaffold, it was imperative that the scaffold be designed to resist these impact loads. It was also important that the laborers be tied-off independently from the scaffold and that foot protection be worn. Final disposition of the concrete to the chamber floor was achieved by allowing the concrete chunks to fall between the scaffold and the lock wall.

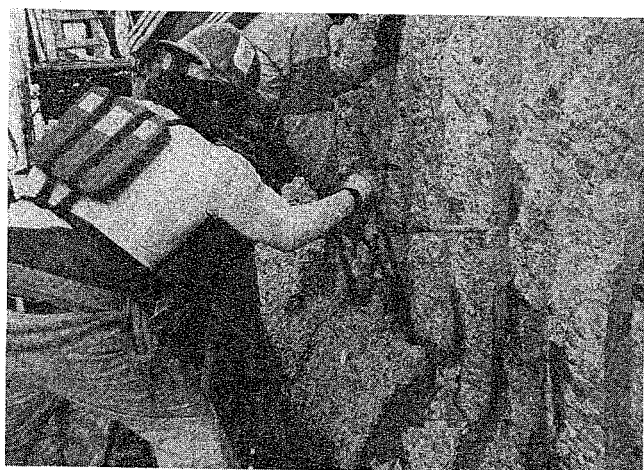
Figure 5. Pry bars aid in final removal of concrete

the crack to continue in zipper-like fashion. By using this method, the laborers were able to remove individual chunks of concrete as large as 1-1/2 by 6 ft. Final removal was accomplished with the aid of jack hammers and pry bars (Fig. 5).
